**Comparison of the Chromium Distribution in New Super Koropon
Primer to 30 Year Old Super Koropon Using Focused Ion
Beam/Scanning Electron Microscopy**

Janice K. Lomness and Luz Marina Calle
Corrosion Technology Laboratory
NASA, Kennedy Space Center

Eric Eichinger
Materials & Processes/Test & Evaluation
Huntington Beach Development Center
Huntington Beach Engineering

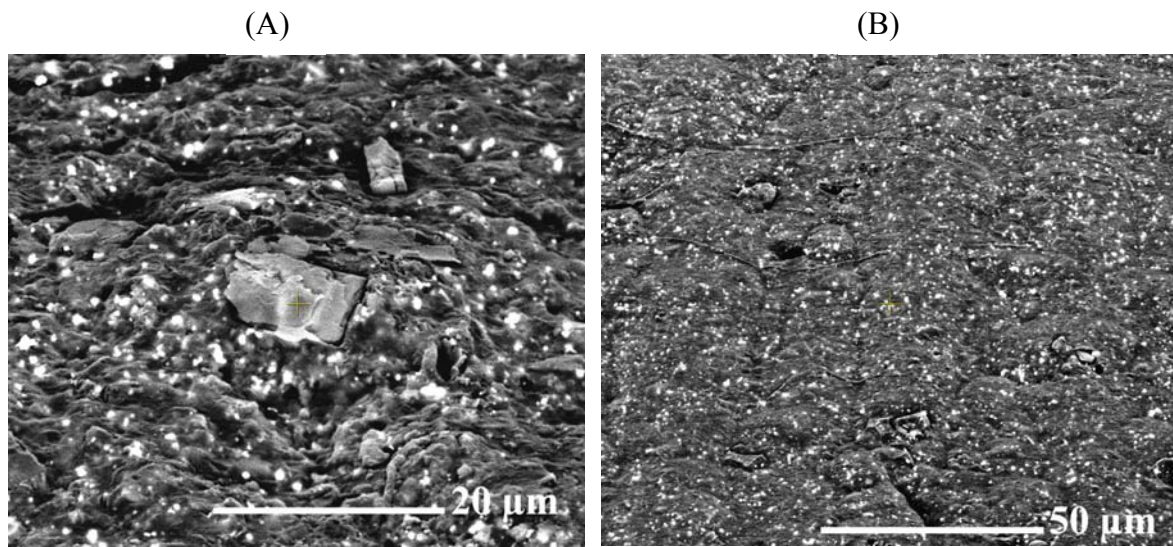
The SEM images of the surface of the Koropon sample from the Orbiter Enterprise and the control Koropon sample are shown in Figures 1(A) and 1(B), respectively. Even though the SEM image of the surface of the Enterprise sample is at a slightly higher magnification, the differences in the two surfaces are readily apparent. The surface of the Enterprise sample is very rough and “flakey” while the surface of the control sample appears to be much smoother. The chromium is very visible on both surfaces. The chromium appears as light “dots” on the surface of both samples. A higher magnification

Figure 1. (A) BSE-SEM image of the surface of the Koropon sample from the Orbiter Enterprise. (B) BSE-SEM image of the surface of the Koropon from the control sample.

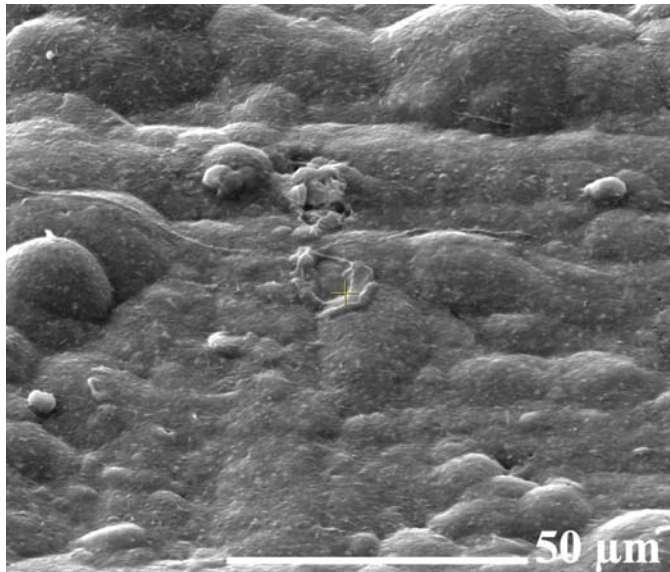
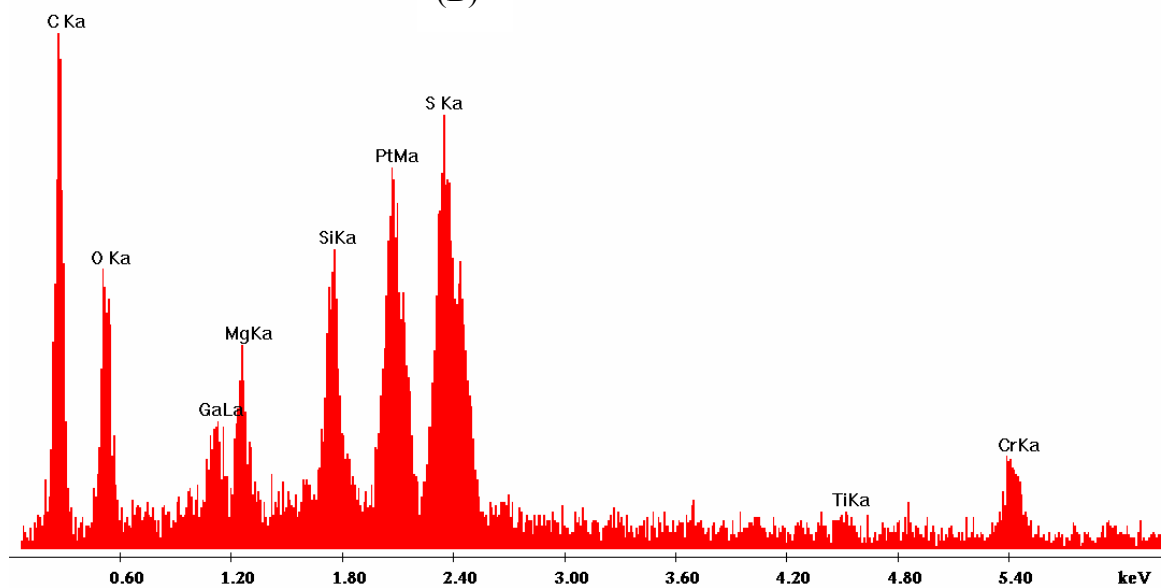
FIB image of the surface of the control Koropon sample is shown in Figure 2(A). The smooth surface can be seen in much greater detail in this image. A region containing chromium is also labeled in the image and the SEM/XEDS spectrum obtained from this region is shown in Figure 2(B). The platinum in the spectrum may be attributed to the platinum that was deposited on the surface to protect the region of interest from damage during the milling process. The gallium may be attributed to the gallium ion beam used to image in FIB mode and also used to mill the SEM trench cut. The titanium and oxygen in the spectrum may be attributed to the paint used to mount the sample. The sulfur, silicon, magnesium, and carbon may be attributed to the epoxy resin of the Koropon matrix.

Figure 2. (A) FIB image of a region of the surface on the control Koropon sample. (B) SEM/EDS of the chromium region of the surface of the control Koropon sample shown in (A).

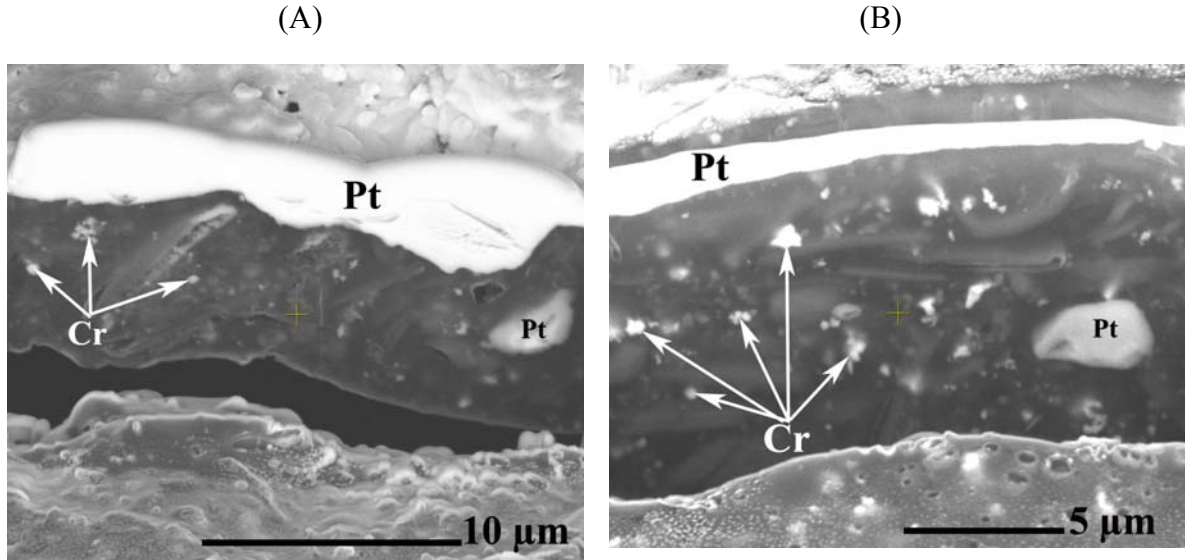
The cross-section BSE-SEM images for the Enterprise Koropon and the control Koropon films are shown in Figure 3(A) and 3(B), respectively. The platinum pad that was deposited to protect the surface of the region of interest from the gallium ion beam during milling is labeled in both images. There was also a void (labeled Pt in the bulk matrix)

that filled with redeposited platinum during milling. Again, the chromium appears as light “dots” and/or very light regions in both images. There are some regions of chromium just beneath the surface that appears as light gray areas. The overall particle size distribution varies widely, however some of the chromium particles were larger than expected. This may be due to some particle agglomeration.

The SEM image of the Enterprise Koropon sample shows that there is a significantly reduced level of chromium in the coating in this region as compared to the new Koropon film. A region $25\ \mu\text{m} \times 8\ \mu\text{m} \times 5\ \mu\text{m}$ was milled (each slice was 162 nm thick) to determine the distribution of chromium over a selected area. SEM images were obtained after each slice. These SEM images show that the chromium appears to be poorly distributed within the film. In fact, there were areas of the old Koropon film that had even less chromium than was observed in Figure 3(A), while other areas had higher chromium content.

The control sample appeared to have a considerably increased quantity of chromium as compared to the Enterprise sample. The chromium in the control film also appeared to be more evenly distributed. Examples of the SEM-XEDS data obtained from the chromium regions of both samples are shown in Figure 4(A) and 4(B). The chromium $K\alpha$ energy for both Koropon samples can be observed at 5.414 keV in the spectra. Because the electron beam is large and the chromium regions are small, XEDS data from the surrounding matrix and platinum layer can be observed in the spectra.

Figure 3. (A) BSE-SEM image of the Enterprise Koropon sample showing the chromium distribution throughout the matrix in this region. (B) BSE-SEM image of the control Koropon sample showing the chromium distribution throughout the matrix in this region.

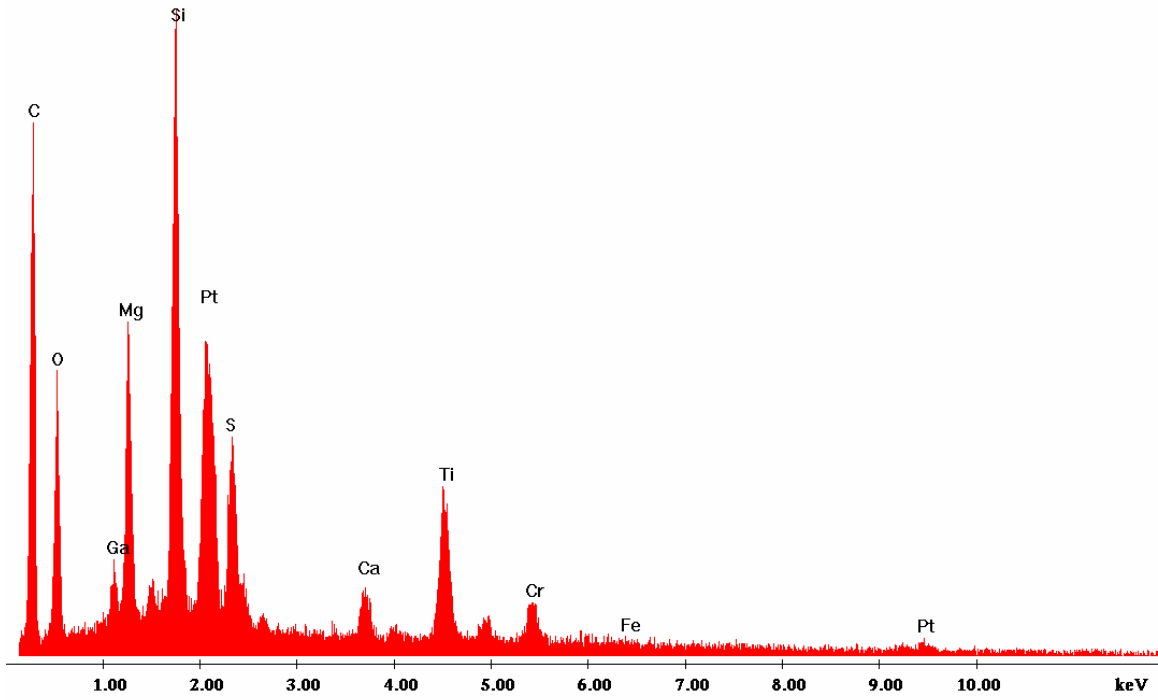
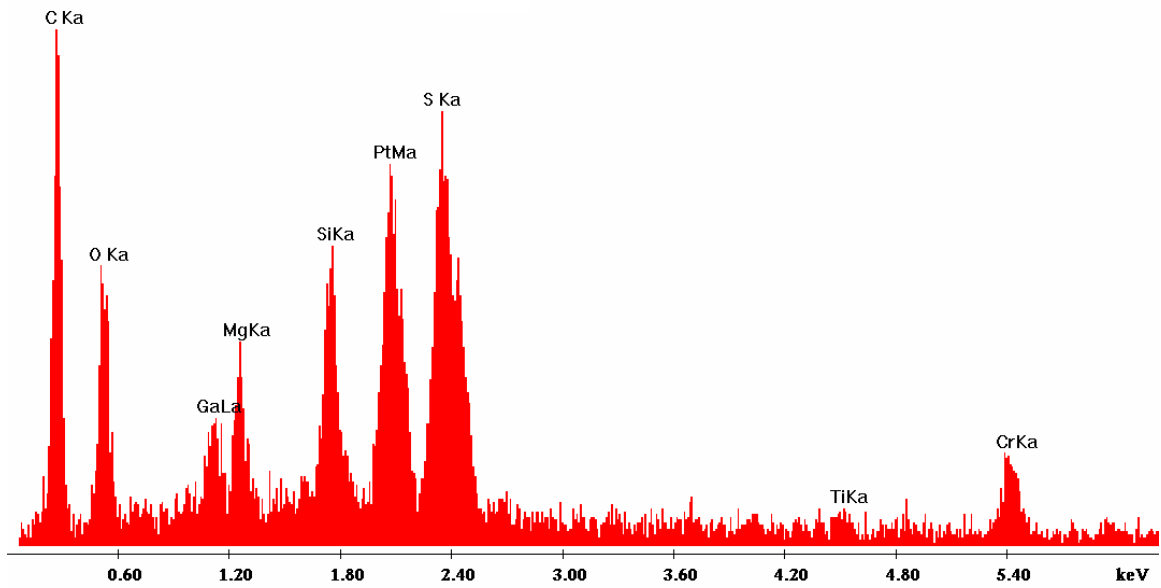
Figure 4. (A) SEM/XEDS Spectrum of the region denoted by the middle arrow in Figure 3(A). (B) SEM/XEDS Spectrum of the region denoted by the second arrow from the right in Figure 3(B).

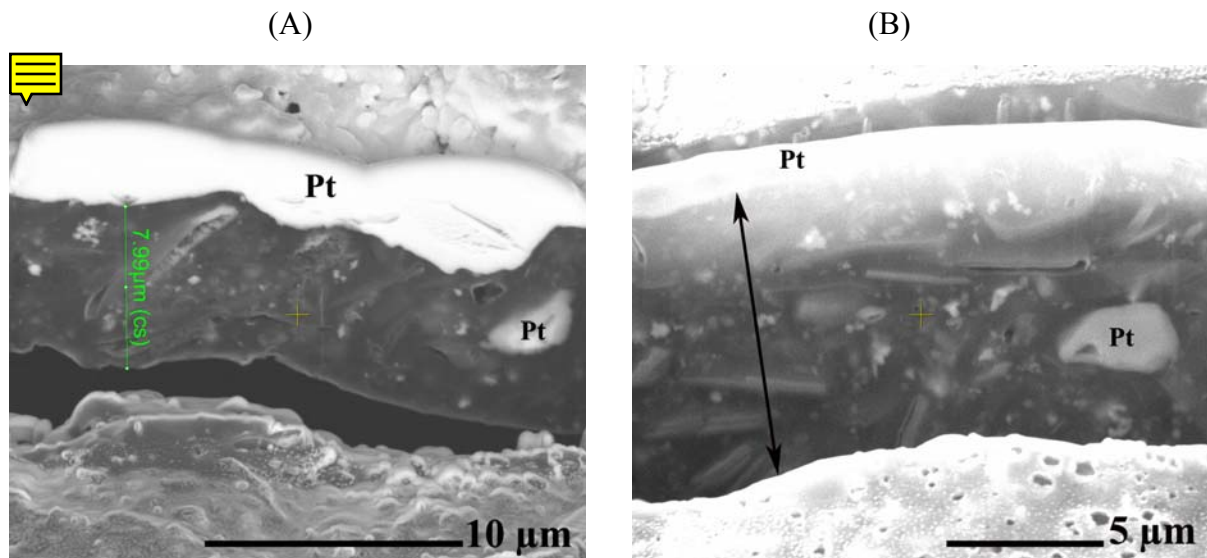
Another interesting observation was the difference in coating thickness. The Enterprise Koropon film, Figure 5(A), was approximately 8 μm (0.000315 inches) thick where as the control Koropon coating, Figure 5(B), was more than 10.5 μm (0.000413 inches) thick. Note that the sample was not cut all the way through. This measurement suggests that the old Koropon film was much too thin since the specified Koropon thickness is 0.(0006 to 0.0009 inches). One possible explanation for this discrepancy is degradation of the polymer matrix of the Enterprise Koropon film as a result of aging and/or as a result of interaction with the stripper used to remove the coating from the panel. This is very plausible since the physical appearance of the Enterprise Koropon sample and the control Koropon sample differed. The old Koropon film was slightly darker in color and appeared to be more brittle than the control Koropon film.

Figure 5. (A) BSE SEM image of the cross-section of the Enterprise Koropon sample used for the measurement of the thickness of the film. (B) SEM image of the cross-section of the control Koropon sample used for measurement of film thickness. (Note that the measurement bar would not save on this image. The location of the thickness measurement is denoted by the arrow).

The inconsistency in the thickness of the coating of the Enterprise Koropon and the specified Koropon thickness may be due to degradation of the polymer as a result of aging and/or the degradation as a result of chemical interaction between the polymer and stripper used to remove the coating from the access panel.
